Intel[®] Celeron[®] Processor in the 478-Pin Package Specification Update

Release Date: June 2002

Order Number: 290749-002

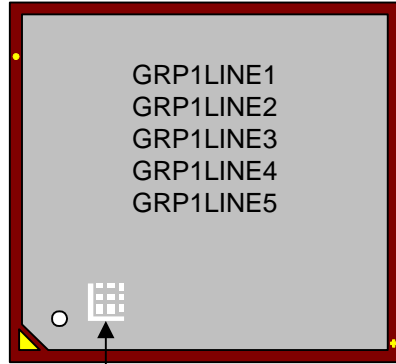
Intel® Celeron® Processor in the 478-pin Package

2-D Matrix Mark

GRP1LINE1 = Intel (M) (C) '02
 GRP1LINE2 = Celeron®
 GRP1LINE3 = Frequency/Cache/Bus/Voltage
 GRP1LINE4 = S-Spec/Country of Origin
 GRP1LINE5 = FPO – Serial Number
